# Manhole Inspection Summary

Manhole # S41K\_\_010MH

**Location** Address: **829 eastern ave**

Cross Street: **albemarle st**

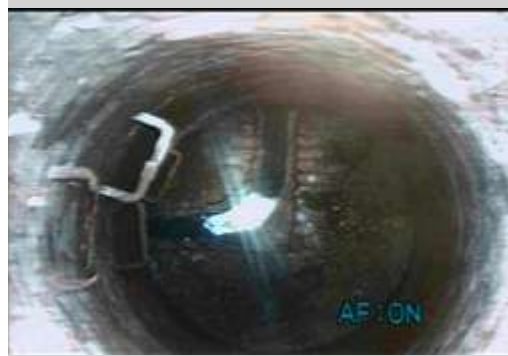
Top View

top view & steps

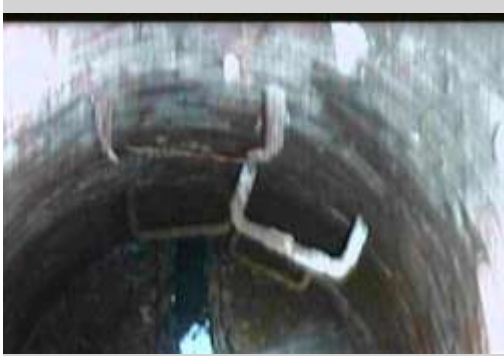
Defect 2

**Steps** Count: **5** Missing: **1** ☒ **Corroded**

steps

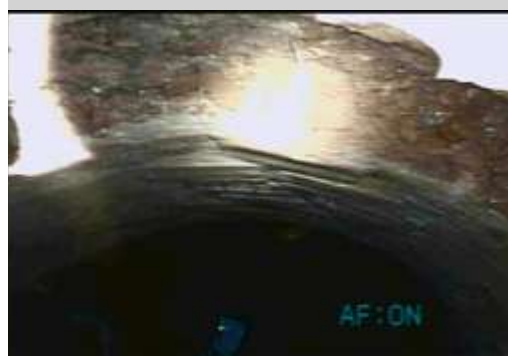
Defect 1

**Frame** Offset: **4** (in.) Condition: ☒ Sound ☐ Cracked ☐ Leaks

offset

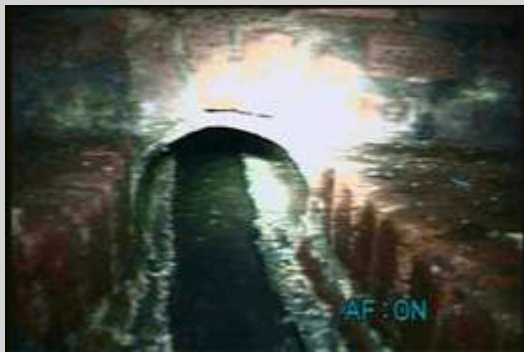
12 O'Clock Outflow

8 in. Circular Gravity Sewer  
Pipe Out @ 12 O'Clock

Pipe Material: **Clay** ☐ Pipe Lined

Invert Depth: **13.03** (ft.) Flow Characteristics: **Slow**

Deposits: ☒ None ☐ Mud ☐ Sludge ☐ Debris ☐ Grease

Infiltration: **None** Pipe Seal Cond: **Unknown**

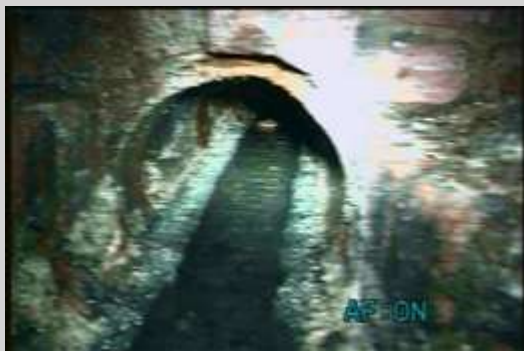
9 O'Clock Inflow

8 in. Circular Gravity Sewer  
Pipe In @ 9 O'Clock

Pipe Material: **Clay** ☐ Pipe Lined

Invert Depth: **12.96** (ft.) Flow Characteristics: **Slow**

Deposits: ☒ None ☐ Mud ☐ Sludge ☐ Debris ☐ Grease

Infiltration: **None** Pipe Seal Cond: **Unknown**
